## ***BIRD Update***

Pervious concrete pavement is exposed to various sources of contamination which may clog the void structure and reduce the permeability during the service life of the pavement. We have developed ways to resolve these clogging issues and restore the permeability of pervious pavement if the pavement was originally built with sufficient voids. This cleaning process is also used to prepare the pavement for overlays and other surface repairs.

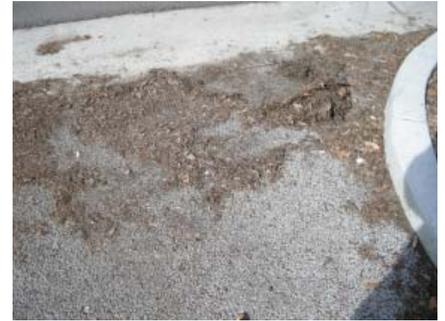
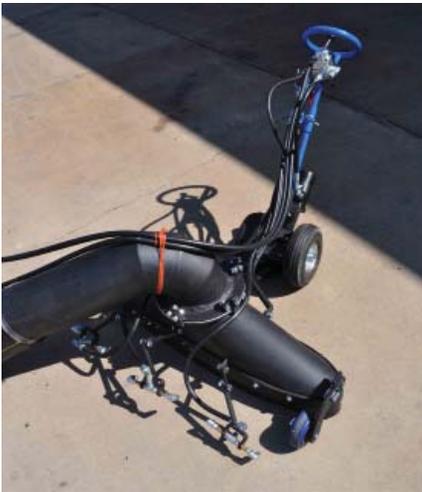
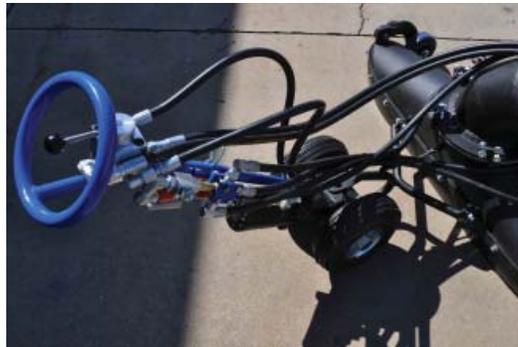
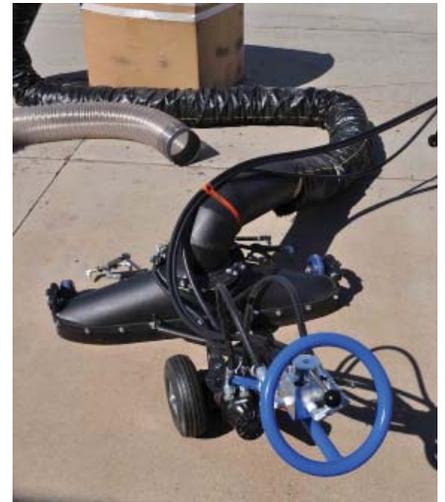
This extraction process for pervious service pulls air through the voids. Performance is at best with a tight seal maintained around the perimeter of the vacuum hood. The hood behaves like the inverse of a hovercraft and represents significant drag, as the hood travels. A drive system propels the device which is tethered to the vacuum source with an extension hose. The height of the hood is set in contact with the surface and adjusted as the rubber belting of the lips wears away. The BIRD is configured on a triangular wheel base and covers a swath that is 42 inches wide.

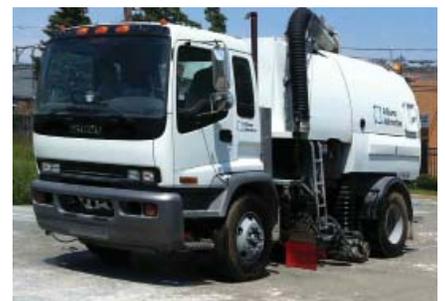
Some vacuum trucks are equipped with a vacuum hood which typically does not seal tightly and travels too rapidly for pervious restoration. Vacuum sweepers in standard configuration will gather loose material from the surface. This is useful for preventative maintenance in removing foreign matter before it becomes impacted in the pavement voids. This type of vacuum is a regenerative fan, designed to cover a lot of area, quickly.

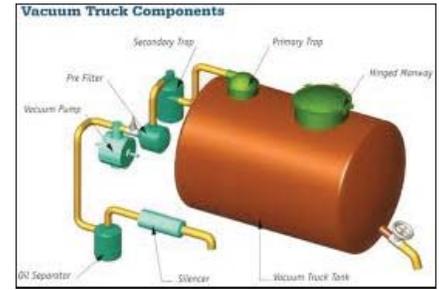
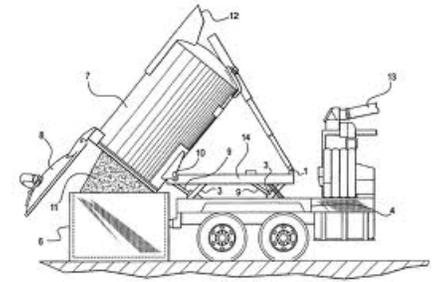
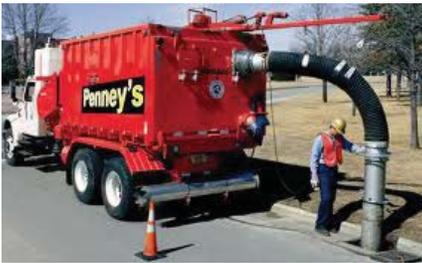
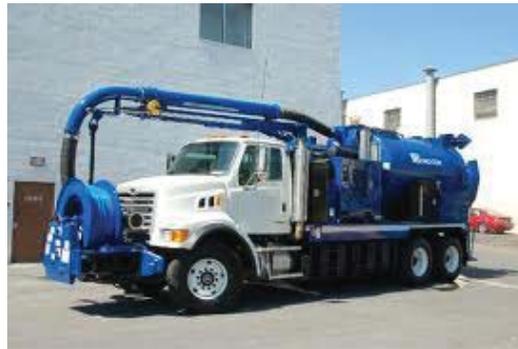
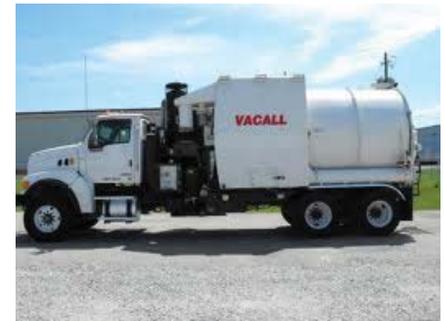
Fan type vacuum equipment usually generates pressure around 7 to 12 inches Hg, and high volume (up to 17,000 cfm). These units are popular for sewer cleaning and can provide high pressure wash water for the optional water circuit on the Bird Vacuum. Six nozzles are available and may be positioned to dislodge debris, ahead of the intake. The volume and pressure of the water system supplied by the vacuum trucks varies and it defines the effectiveness of the pressure washer nozzles. The spray of water is directed at the slab surface, near the rubber lips of the intake. Unless adequate pressurized water supply is aboard the vacuum truck, it is best to use a rotary head or a wand on conventional pressure wash equipment. It is important to operate the BIRD Vacuum in close proximity to the washing operation, to gather debris before it flows to other areas.

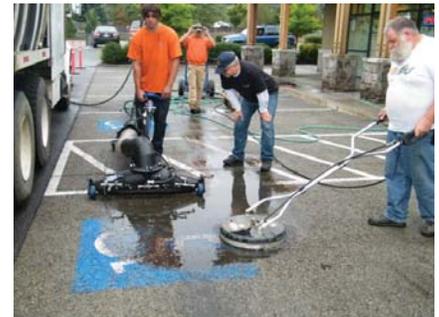
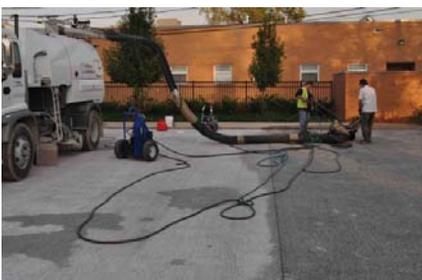
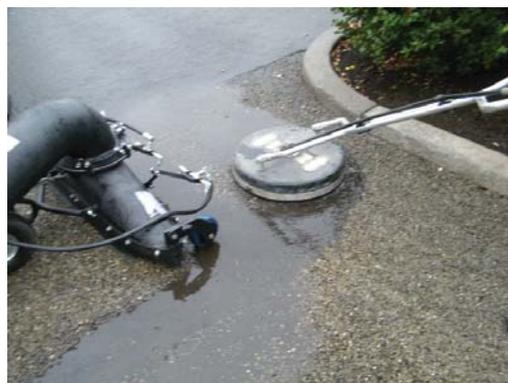
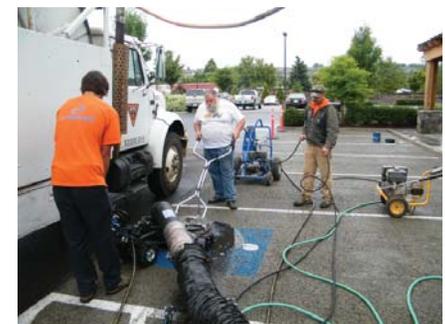
Positive displacement type equipment typically displaces 3,000 to 6,000 cfm of air at significantly greater pressure. For vacuum units with sufficient horsepower and positive displacement, you can expect up to 27 in.Hg. This type of vacuum is used for excavating and has both hot and cold pressurized water available on board. The extraction process is most effective when powered by this type of equipment. However, it will only restore permeability to a slab that was permeable on the day it was constructed.

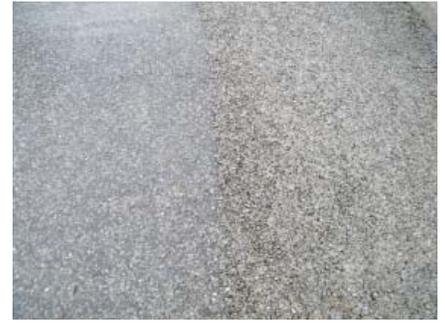
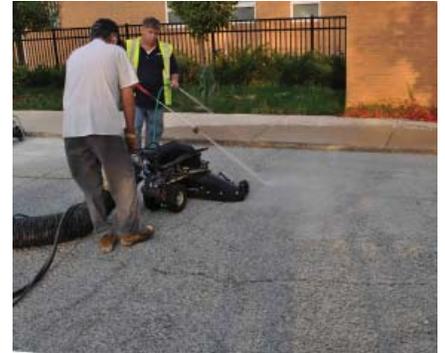
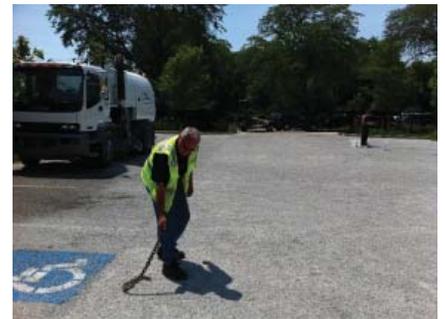
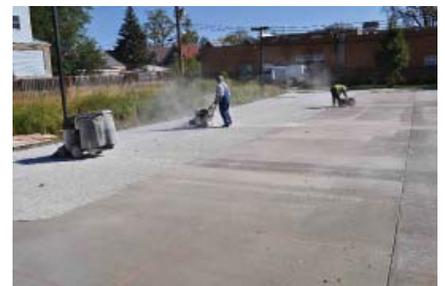
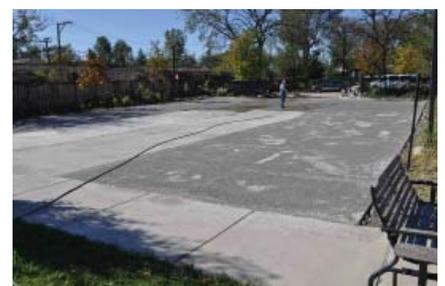
The permeable overlay project is a 6,000 sf site in Chicago. This pervious concrete parking lot was exposed to undue amounts of calcium chloride, used for deicing. The attack was severe, with some places disintegrating the slab down to a depth of 2 inches. Many of the affected areas remained intact at the surface, having been protected by bean oil used for curing during construction. Below the surface materials penetrated by the bean oil, the chloride attack caused extensive damage.

Most of the delaminated areas are easily located with a chain, dragging over the surface. Roto-milling was selected for surface preparation, based on the extent of the damage. Depth of cut was 2.5 inches. The milling process gathered the largest cuttings but left the dust and finer materials laying on the surface for over a month. Rain storms settled the dust into a nasty clog on the milled surface. This was clearly as tough as cleaning gets for our bird vacuum. The mill had chewed the surface down to very rough terrain. This contributed to some difficulty in holding a tight seal at the lips of the intake hood. The pressure washer aboard the vacuum truck was limited. Again, smaller pressure washers were used and gave the best wash with a rotary head. Mr. Brian Lutey is shown using a pressure washer wand, also. Brian is our test pilot for prototypes of the bird vacuum. He graciously agreed to destroy two toad suckers in the course of field trials during development of this equipment.

Time will tell about the performance of the permeable overlay. The milled and cleaned surface was prepared with a nano-silica densifier from Apex Nano. The same densifier was applied to the overlay, after striping. The desired effect is to stop the attack of calcium chloride in the underlayment and create a suitable bond for the overlay. We continue to monitor the white topping on the center lane that covers about 2,000 sf, and the 4,000 sf of permeable overlay at the BTM project, funded by Ozinga in Chicago.

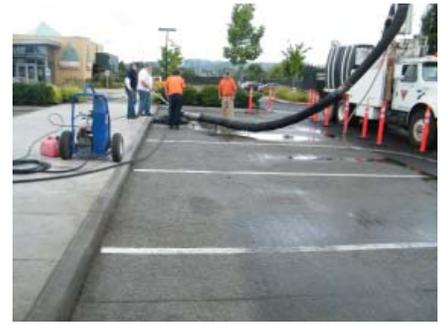
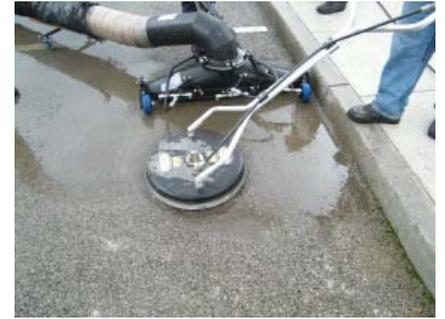
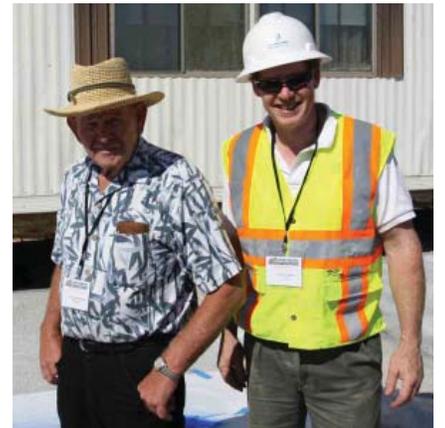
Our other test pilots are at Hildebrand Concrete, in Vancouver, WA. I invited their critical feedback and gave them permission to revise at will. By sundown on the third day, Rick Hildebrand had chopped the hydraulic drive system from the bird and made a self propelled platform with the engine on board. He continues his work as I urged him to focus on two issues. Maneuverability and slow travel are important to get access to edges and tight spots. And, sometimes the process slows to a snail's pace when the hood is well sealed and the extraction is working.

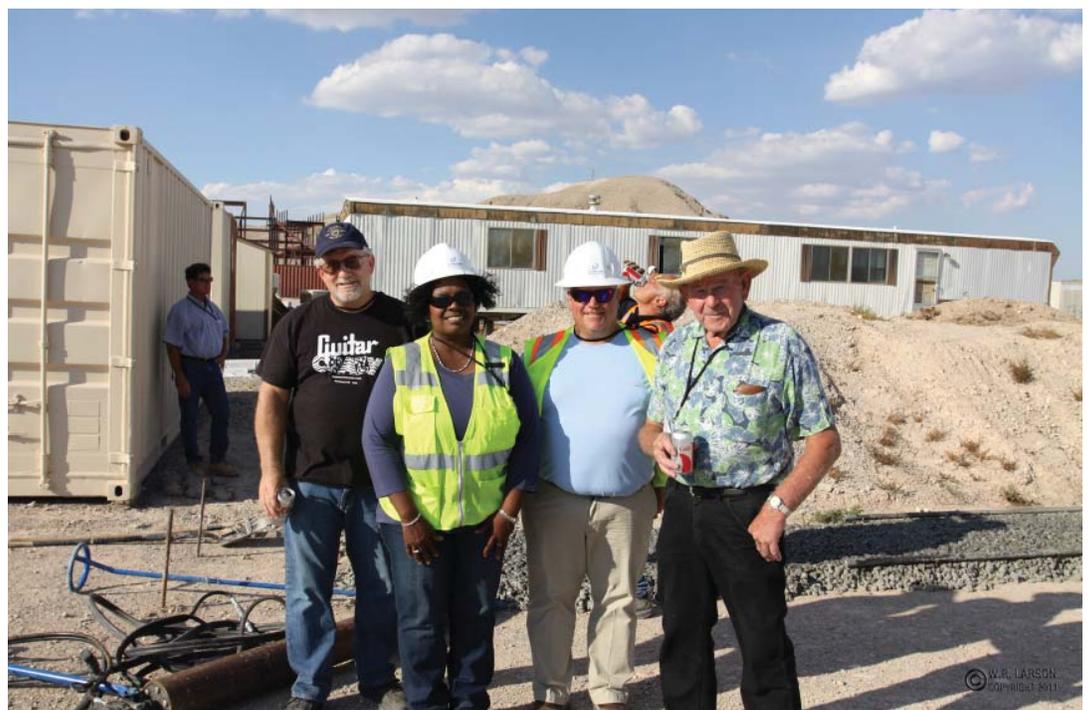
Greg Plumb and the crew at Hildebrand Concrete have discovered a new client base when they showed the ability to "burp the todes" out of pervious concrete pavement. The owners of pervious concrete pavement have a keen interest in doing this process and knowing that this process can be done. Rick discovered the realities of running a positive displacement vacuum truck with enough wood to collapse the intake hose. Then he stuffed it full of rings of pvc pipe, to hold it open. This also helps with the troublesome shortening of the intake hose under extreme vacuum Hg. We appreciate the boldness and creativity that is offered by Rick and Greg. But, mostly I appreciate the participation of George Hildebrand, a legend in the construction of concrete flatwork. His resume shows evidence of his pioneering and his contribution to this industry. We are honored to have him involved and in attendance at the 2011 Bunyan Pervious Roast. Mr. Hildebrand is pictured here with David Frentress, PM2, another legend in the concrete industry.
